Re: PCB Spill

Re: Follow up sampling from previous PCB Fluid
Spill in the Plant Main Substation

PCB SPILL CLEAN UP DOCUMENTATION, Report Amended June 28, 1993

Re: Remediation of PCB spill area.

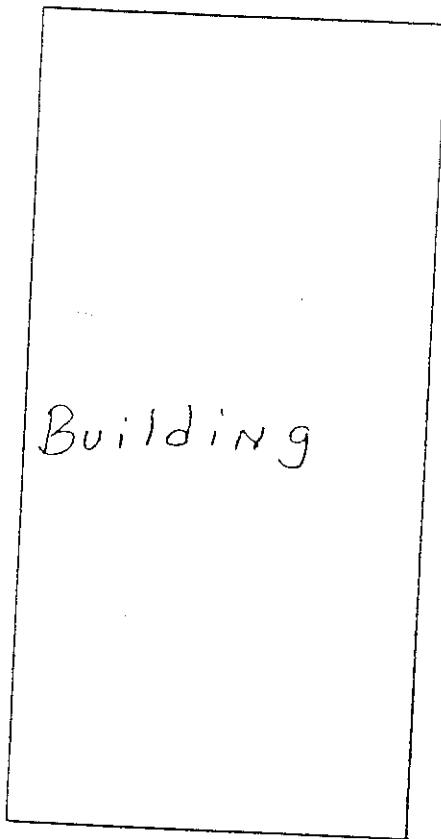
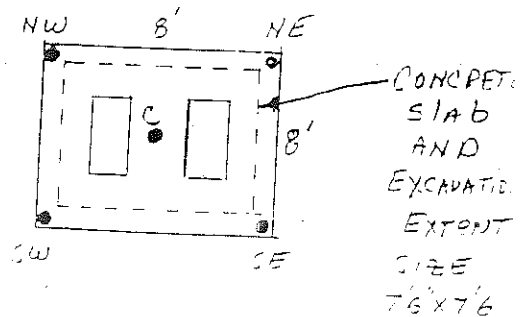
APPENDIX A

On May 4, 1993, Cousins personnel arrived at the spill site for the specific purpose of collecting samples to quantify the extent of the contamination caused by the spill. This spill occurred underneath a small capacitor bank within the plant substation. The area under the capacitor bank was sectioned off for the purpose of establishing a sampling grid. A schematic of the spill area and the collection points of the samples is attached in Appendix A. Samples were taken at the corners of the four boxes at depth intervals of surface, one foot, and two foot. A sample was taken directly beneath the capacitor bank at the depth of one foot. The capacitor bank supports are resting on a concrete slab at a depth of one foot below the surface. The slab is represented in the schematic as the dotted line.

• = sampling points

The results of the analysis are enclosed in Appendix B. From the results of the analysis the area to be remediated was determined. On June 24, 1993, Cousins personnel returned to the site to complete the remediation. The remediation consisted of excavating the contaminated soils beneath the capacitor bank from the surface to the top of the concrete support slab. The extent of the excavation is shown in the schematic in Appendix A. After the excavation, the slab was inspected for the presence of cracks. This inspection revealed that the slab did not have any cracks, thus there is no reason to believe that the contamination went any further. The excavation generated six drums of PCB contaminated waste which were properly labeled and staged for disposal. The maintenance staff at the site provided the clean backfill for the excavation.
